### **WOOD DESTROYING PESTS AND ORGANISMS INSPECTION REPORT**

Address 289 Eastbourne terrace, Santa Maria, CA 93455

W14898

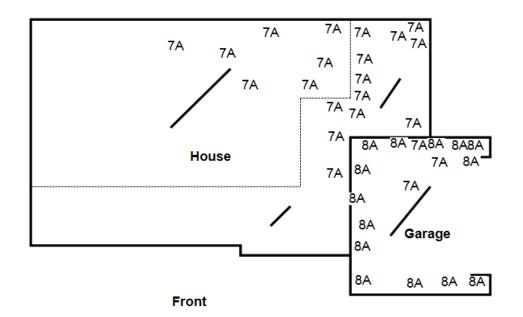
FINDINGS: Evidence of dry-wood termite infestations at attic as indicated on the diagram.

FINDINGS: Evidence of subterranean termite infestation at garage as indicated on the diagram. RECOMMENDATION: Pressure "ROD" treat, trench application or low pressure spot spray as necessary. Break accessible sub tubes.

RECOMMENDATION: Vacate the premises and seal the structure for fumigation with Vikane Gas.

Remove or cover accessible evidence of infestation. Fumigation warranteed for two years. Fumigation awareness notice must be signed prior to fumigation. See fumigation notice for terms and liabilities.
