WOOD DESTROYING PESTS AND ORGANISMS INSPECTION REPORT

| Building Address: 17550 Via Del Bravo, Rancho Sante Fe, CA 92067 | | Date of Inspection 10/07/2016 | Number of Pages 6 |
| Plateau Pest Solutions Inc. 1922 Odell Circle Vista CA 92084 Phone: (619) 507-5575 Fax: (760) 806-4958 | | Report # W8302 | Lic. Registration # PR 7080 |
| General Description: One story wood and stucco framed single family dwelling with 3 car attached garage, on concrete slab, tile roof, vacant at the time of inspection. | | Inspection Tag Posted: Garage | Other Tags Posted: None |

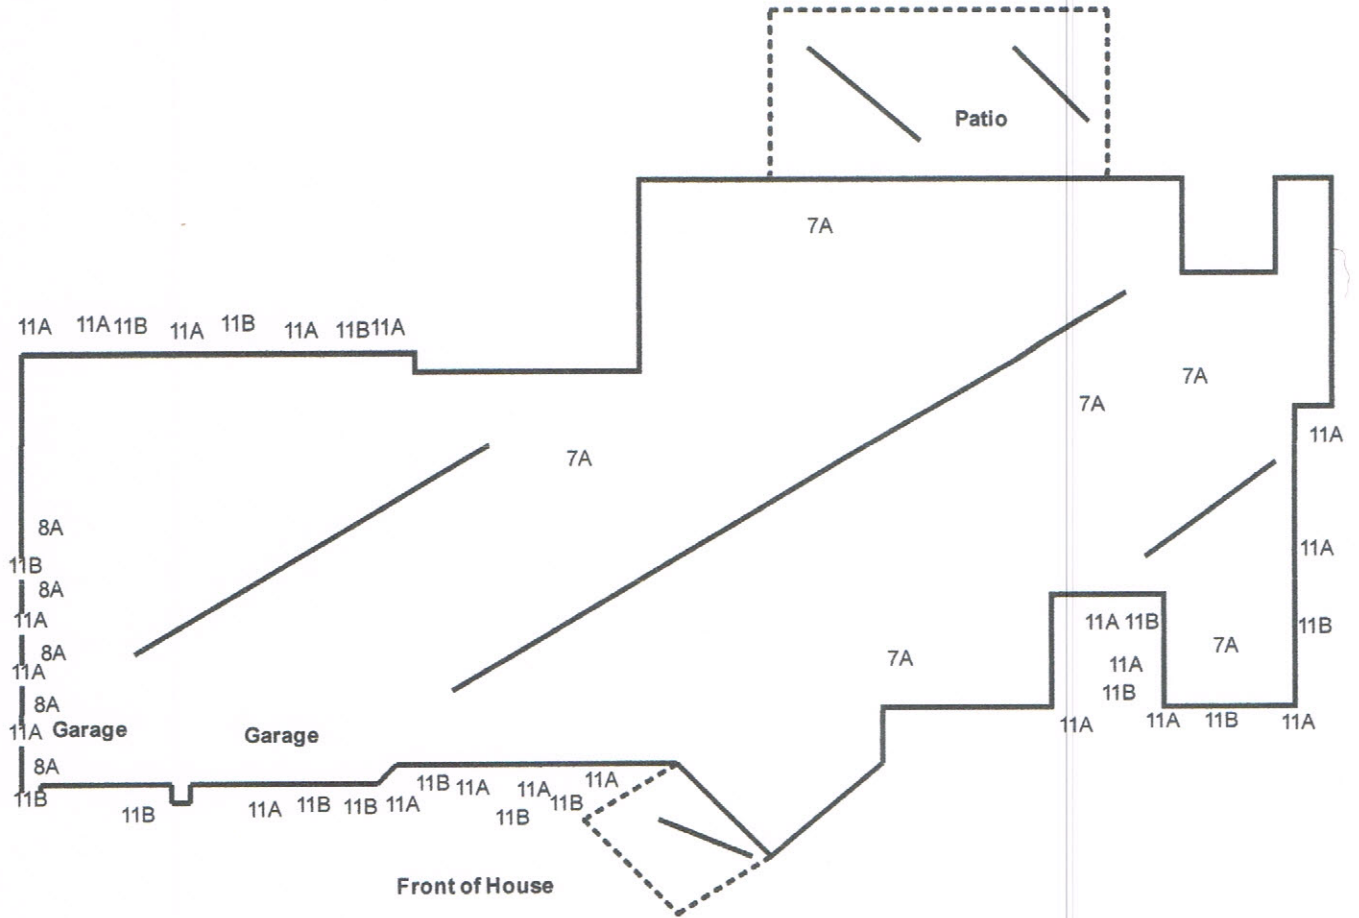
This Diagram is not to scale

7A (Section I)
FINDINGS: Evidence of drywood termite infestation at attic space as indicated on the diagram.
RECOMMENDATION: Vacate the premises and seal the structure for fumigation with Vikane Gas. Remove or cover accessible evidence of infestation. Fumigation warranted for two years. Fumigation awareness notice must be signed prior to fumigation. See fumigation notice for terms and liabilities.

8A (Section I)
FINDINGS: Evidence of drywood termite infestation at interior garage wood members as indicated on the diagram.
RECOMMENDATION: Vacate the premises and seal the structure for fumigation with Vikane Gas. Remove or cover accessible evidence of infestation. Fumigation warranted for two years. Fumigation awareness notice must be signed prior to fumigation. See fumigation notice for terms and liabilities.

11A (Section I)
FINDINGS: Evidence of drywood termite infestation at exterior rafters, sheathing and blocking timbers as indicated on the diagram as 11A.
RECOMMENDATION: Vacate the premises and seal the structure for fumigation with Vikane Gas. Remove or cover accessible evidence of infestation. Fumigation warranted for two years. Fumigation awareness notice must be signed prior to fumigation. See fumigation notice for terms and liabilities.

- 11B (Section I)
FINDINGS: Evidence of termite damaged wood members noted at time of inspection at exterior facia, blocking, sheathing, and rafters as indicated on the diagram.
RECOMMENDATION: Replace and repair all damaged wood members as necessary. White primer painting is included in this estimate. If additional adverse conditions are uncovered during repairs, further inspection will be recommended and a supplemental report will be issued indicating any infection, or additional repairs.
