Subject Details

Analysis Of Subject

Subject Photos

Property Condition Inspection

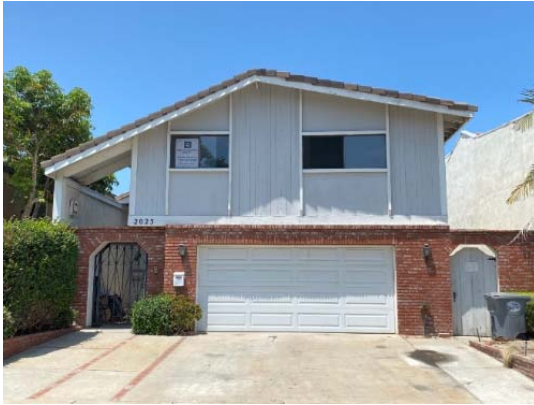
CONDITION	⚠ Fair	Home needs trim and facia work, there is dry rot and peeling paint. There is debris and garbage that needs to be removed from the front entry and side yard.
SIGNIFICANT REPAIRS NEEDED	✓ No	From the exterior, needed repairs appear to only be cosmetic.
CURRENT ZONING VIOLATIONS/ POTENTIAL ZONING CHANGES	✓ No	No apparent zoning violations.
SUBJECT CONFORMITY TO NEIGHBORHOOD (QUALITY, AGE, STYLE, & SIZE)	✓ Yes	-
AVERAGE CONDITION OF NEIGHBORING PROPERTIES	✓ Good	Surrounding homes are in average to good condition. There were some homes under renovation or possibly expansion. The area is generally well maintained.
BOARDED OR VACANT PROPERTIES NEAR SUBJECT	✓ No	None noted.
SUBJECT NEAR POWERLINES	✓ No	-
SUBJECT NEAR RAILROAD	✓ No	-
SUBJECT NEAR COMMERCIAL PROPERTY	✓ No	-

ITEM	COMMENTS	COST
Exterior Paint	facia and trim	\$1,500
Siding/Trim Repair	repair and prep for paint	\$2,500
Exterior Doors	-	\$0
Windows	-	\$0
Garage /Garage Door	-	\$0
Roof/Gutters	-	\$0
Foundation	-	\$0
Fencing	-	\$0
Landscape	-	\$0
Pool /Spa	-	\$0
Deck/Patio	-	\$0
Driveway	-	\$0
Other	debris removal	\$500
TOTAL EXTERIOR REPAIRS		\$4,500
